**Flood Control Project Maintenance
Levee Inspections**

Maintenance Issue Types Only, Levee Inspection Report By Mile - Spring 2015

Reclamation District No. 1001 Nicolaus

Waterway	Bank	Unit Miles	Inspection Start/End	Inspector
Unit No. 01 Yankee Slough	Right	4.12	05/18/2015 05/18/2015	Michael Pitta

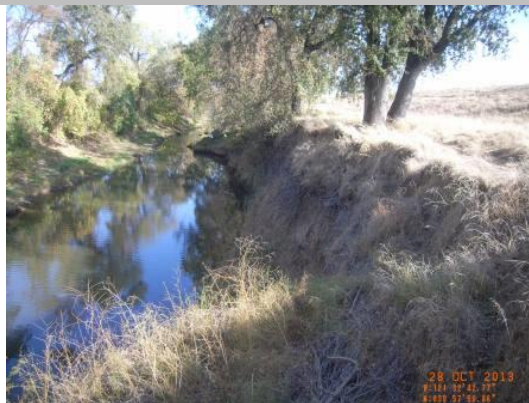
Photo 1 of 1 : SP_2015_RD1001_37_17_20150401_00009.jpg

LM Start	10.36	Rating **	M	Issue No.	17
LM End	10.40	Issue Type +	Ma	Location *	WS
Category	Supplemental			GPS Latitude/Longitude	
				Start	End
Item	USACE Erosion Survey			38.964583 °	38.964010 °
				-121.544967 °	-121.545228 °
DWR ID	DWR_RD1001_03_f_2014_17				
Action/Comments					
Inspector Comments: 2011 - Large section of bank has slumped off. RD has flagged and appears to be watching. 2012 - Slopes slightly steeper. 2013: Minor new erosion. [2013 Site ID: BER_2-5_L]

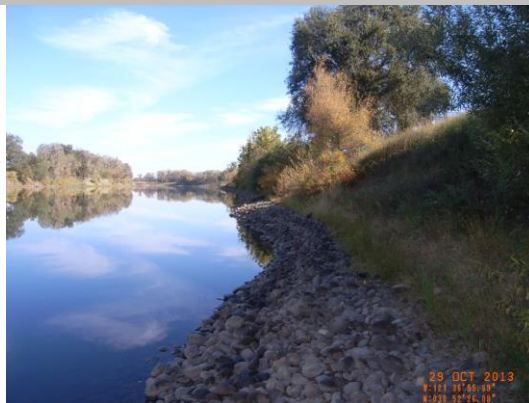
Photo 1 of 1 : SP_2015_RD1001_38_8_20150401_00008.jpg

LM Start	5.80	Rating **	M	Issue No.	8
LM End	5.93	Issue Type +	Ma	Location *	WS
Category	Supplemental			GPS Latitude/Longitude	
				Start	End
Item	USACE Erosion Survey			38.874113 °	38.872373 °
				-121.615380 °	-121.616504 °
DWR ID	DWR_RD1001_04_f_2014_8				
Action/Comments					
Inspector Comments: 2011 - Erosion pockets from tree popouts. Sections of the lower bank have slumped off. 2013: Scallops from tree popouts no longer visible on site. Minor new erosion at the middle of the bank. [2013 Site ID: FHR_6-6_L]

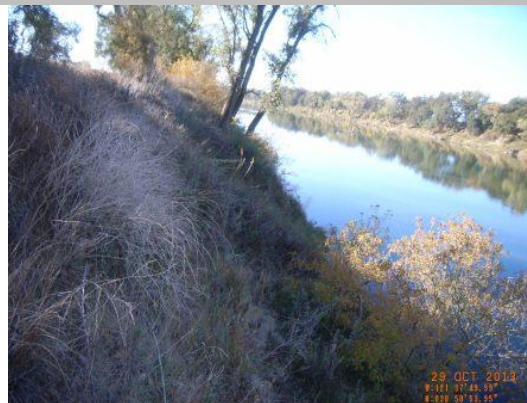
Photo 1 of 1 : SP_2015_RD1001_38_5_20150401_00005.jpg

LM Start	7.47	Rating **	M	Issue No.	5
LM End	7.86	Issue Type +	Ma	Location *	WS
Category	Supplemental			GPS Latitude/Longitude	
				Start	End
Item	USACE Erosion Survey			38.852394 °	38.848004 °
				-121.629231 °	-121.630873 °
DWR ID	DWR_RD1001_04_f _ 2014_5				
Action/Comments					
Inspector Comments: 2000 - Steep bank off berm with some slumps and fallen trees, continued erosion. 2002 - Site lengthened upstream and downstream due to vertical bank along most of the reach. 2010 - Site extended upstream. 2011 - Minimal new erosion. 2012 - Site extended on the upstream end, new tree pop-out, and bank erosion continues to worsen. 2013: Minor new erosion at the toe and top of bank. [2013 Site ID: FHR_5-0_L]

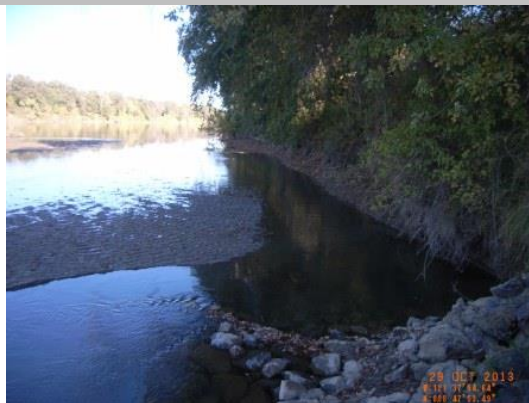
Photo 1 of 1 : SP_2015_RD1001_38_2_20150401_00002.jpg

LM Start	11.19	Rating **	M	Issue No.	2
LM End	11.44	Issue Type +	Ma	Location *	WS
Category	Supplemental			GPS Latitude/Longitude	
				Start	End
Item	USACE Erosion Survey			38.800920 °	38.798165 °
				-121.633050 °	-121.631939 °
DWR ID	DWR_RD1001_04_f_2014_2				
Action/Comments					
Inspector Comments: 2000 - Site is relatively stable except for some toe erosion at the upstream end, recommend monitoring the upstream end. 2004 - Some new block failures (10ft deep) at the toe of the upstream end. 2007 - Some minor new slumping at the waterline. 2013: Minor new erosion along the toe of the bank. [2013 Site ID: FHR_1-0_L]

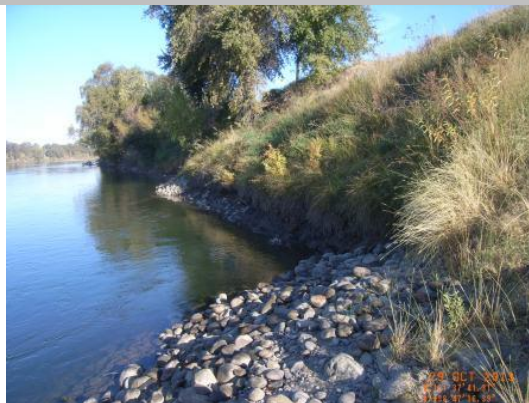
Photo 1 of 1 : SP_2015_RD1001_38_1_20150401_00001.jpg

LM Start	11.68	Rating **	M	Issue No.	1
LM End	11.85	Issue Type +	Ma	Location *	WS
Category	Supplemental			GPS Latitude/Longitude	
				Start	End
Item	USACE Erosion Survey			38.795455 °	38.793394 °
				-121.629903 °	-121.628156 °
DWR ID	DWR_RD1001_04_f_2014_1				
Action/Comments					
Inspector Comments: 1997- Deposits over top of cobble on the upper slope. 2000 - Old cobble site in poor shape; some toe retreat, but little change; steep bank. 2010 - Site extended upstream due to new toe erosion. 2012 - Minor new erosion at toe, new slumping, animals holes and cracks observed. 2013: No observed changes. [2013 Site ID: FHR_0-6_L]
